EPA Internal Update: August 17, 2015 1345 ET

Overview: On August 5, a large release of mine wastewater into Cement Creek occurred while an EPA site assessment team was conducting site investigation activities. Loose material collapsed into the cave entry and pressurized water began leaking above the mine tunnel, spilling an estimated three million gallons of water stored behind the collapsed material into Cement Creek, a tributary of the Animas River. The release's path currently flowed through three of EPA's regions: Region 8—Colorado, Utah and the Southern Ute Tribe; Region 6--New Mexico; and, Region 9--Navajo Nation. The mine water is being treated in a series of four settling ponds constructed near the portal. The La Plata County Sheriff opened the Animas River to recreational use on August 14 with a health advisory from Colorado Department of Public Health and Environment (CDPHE). EPA's Airborne Spectral Photometric Environmental Collection Technology (ASPECT) aerial reconnaissance combined with observations on the ground indicate that the plume associated with the Gold King Mine release has dissipated downstream. There is no leading edge of contamination visible in downstrea

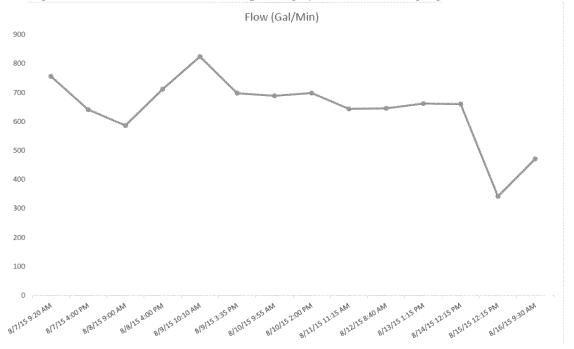
Flow from the mine through the morning of August 16 is shown in the following chart.

Treated water from the last treatment pond is discharging into Cement Creek. Flow data out of the mine is being collected manually two times per day. Water quality data is being collected at the influent and effluent of the treatment system as well.
